# Integrated Water Cycle Management Strategy, Mixed Use Urban Development at West Culburra, NSW

Prepared for Sealark Pty Ltd

Report No: 1203365JR07

17 November 2020

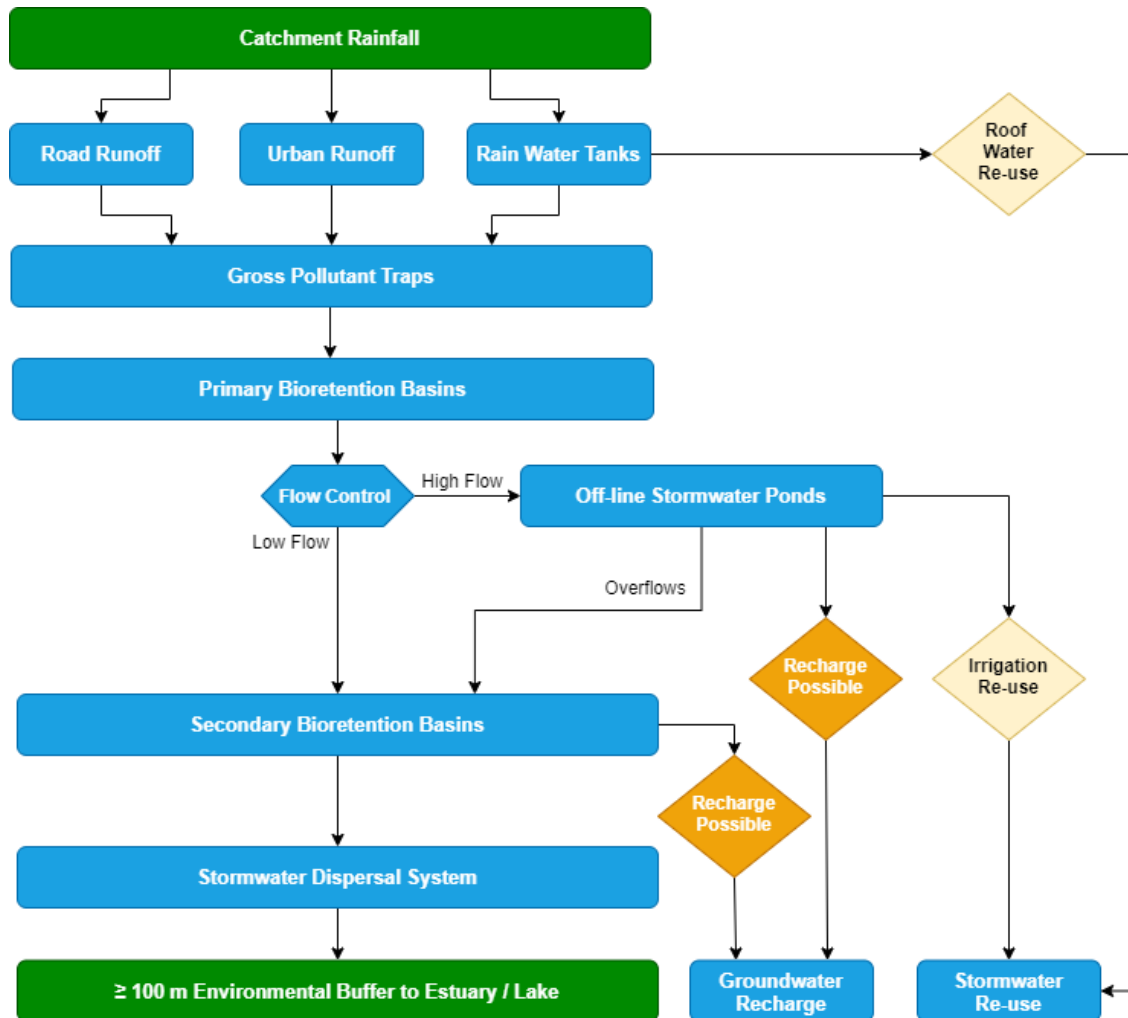
recharge. These general concepts are illustrated in the figure below, which broadly describes the stormwater scheme layout for the majority of the site. Only a small portion of the Proposal area is not serviced by an off-line stormwater pond and a secondary bioretention basin.

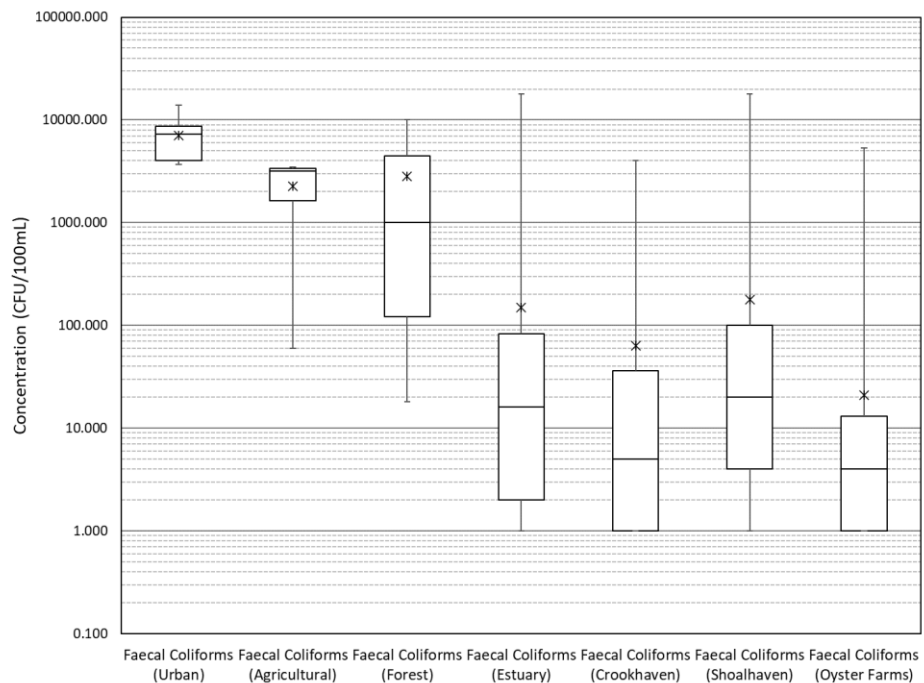
Diagram 9: Faecal Coliform (FC) box-whisker plots of observed surface runoff and estuary concentrations.

- (e) Catchment surface runoff Faecal Coliform interquartile ranges are significantly higher than those reported for the Estuary, this reflecting the sanitising effect of a large body of salt water. Higher 'spike' levels were however evident in Council's monitoring data which fall in the range of surface runoff. It is worth noting that the observations for forest runoff are not too dissimilar from that found in urban runoff, indicating that wildlife may contribute significantly to pathogen loads to the Estuary.

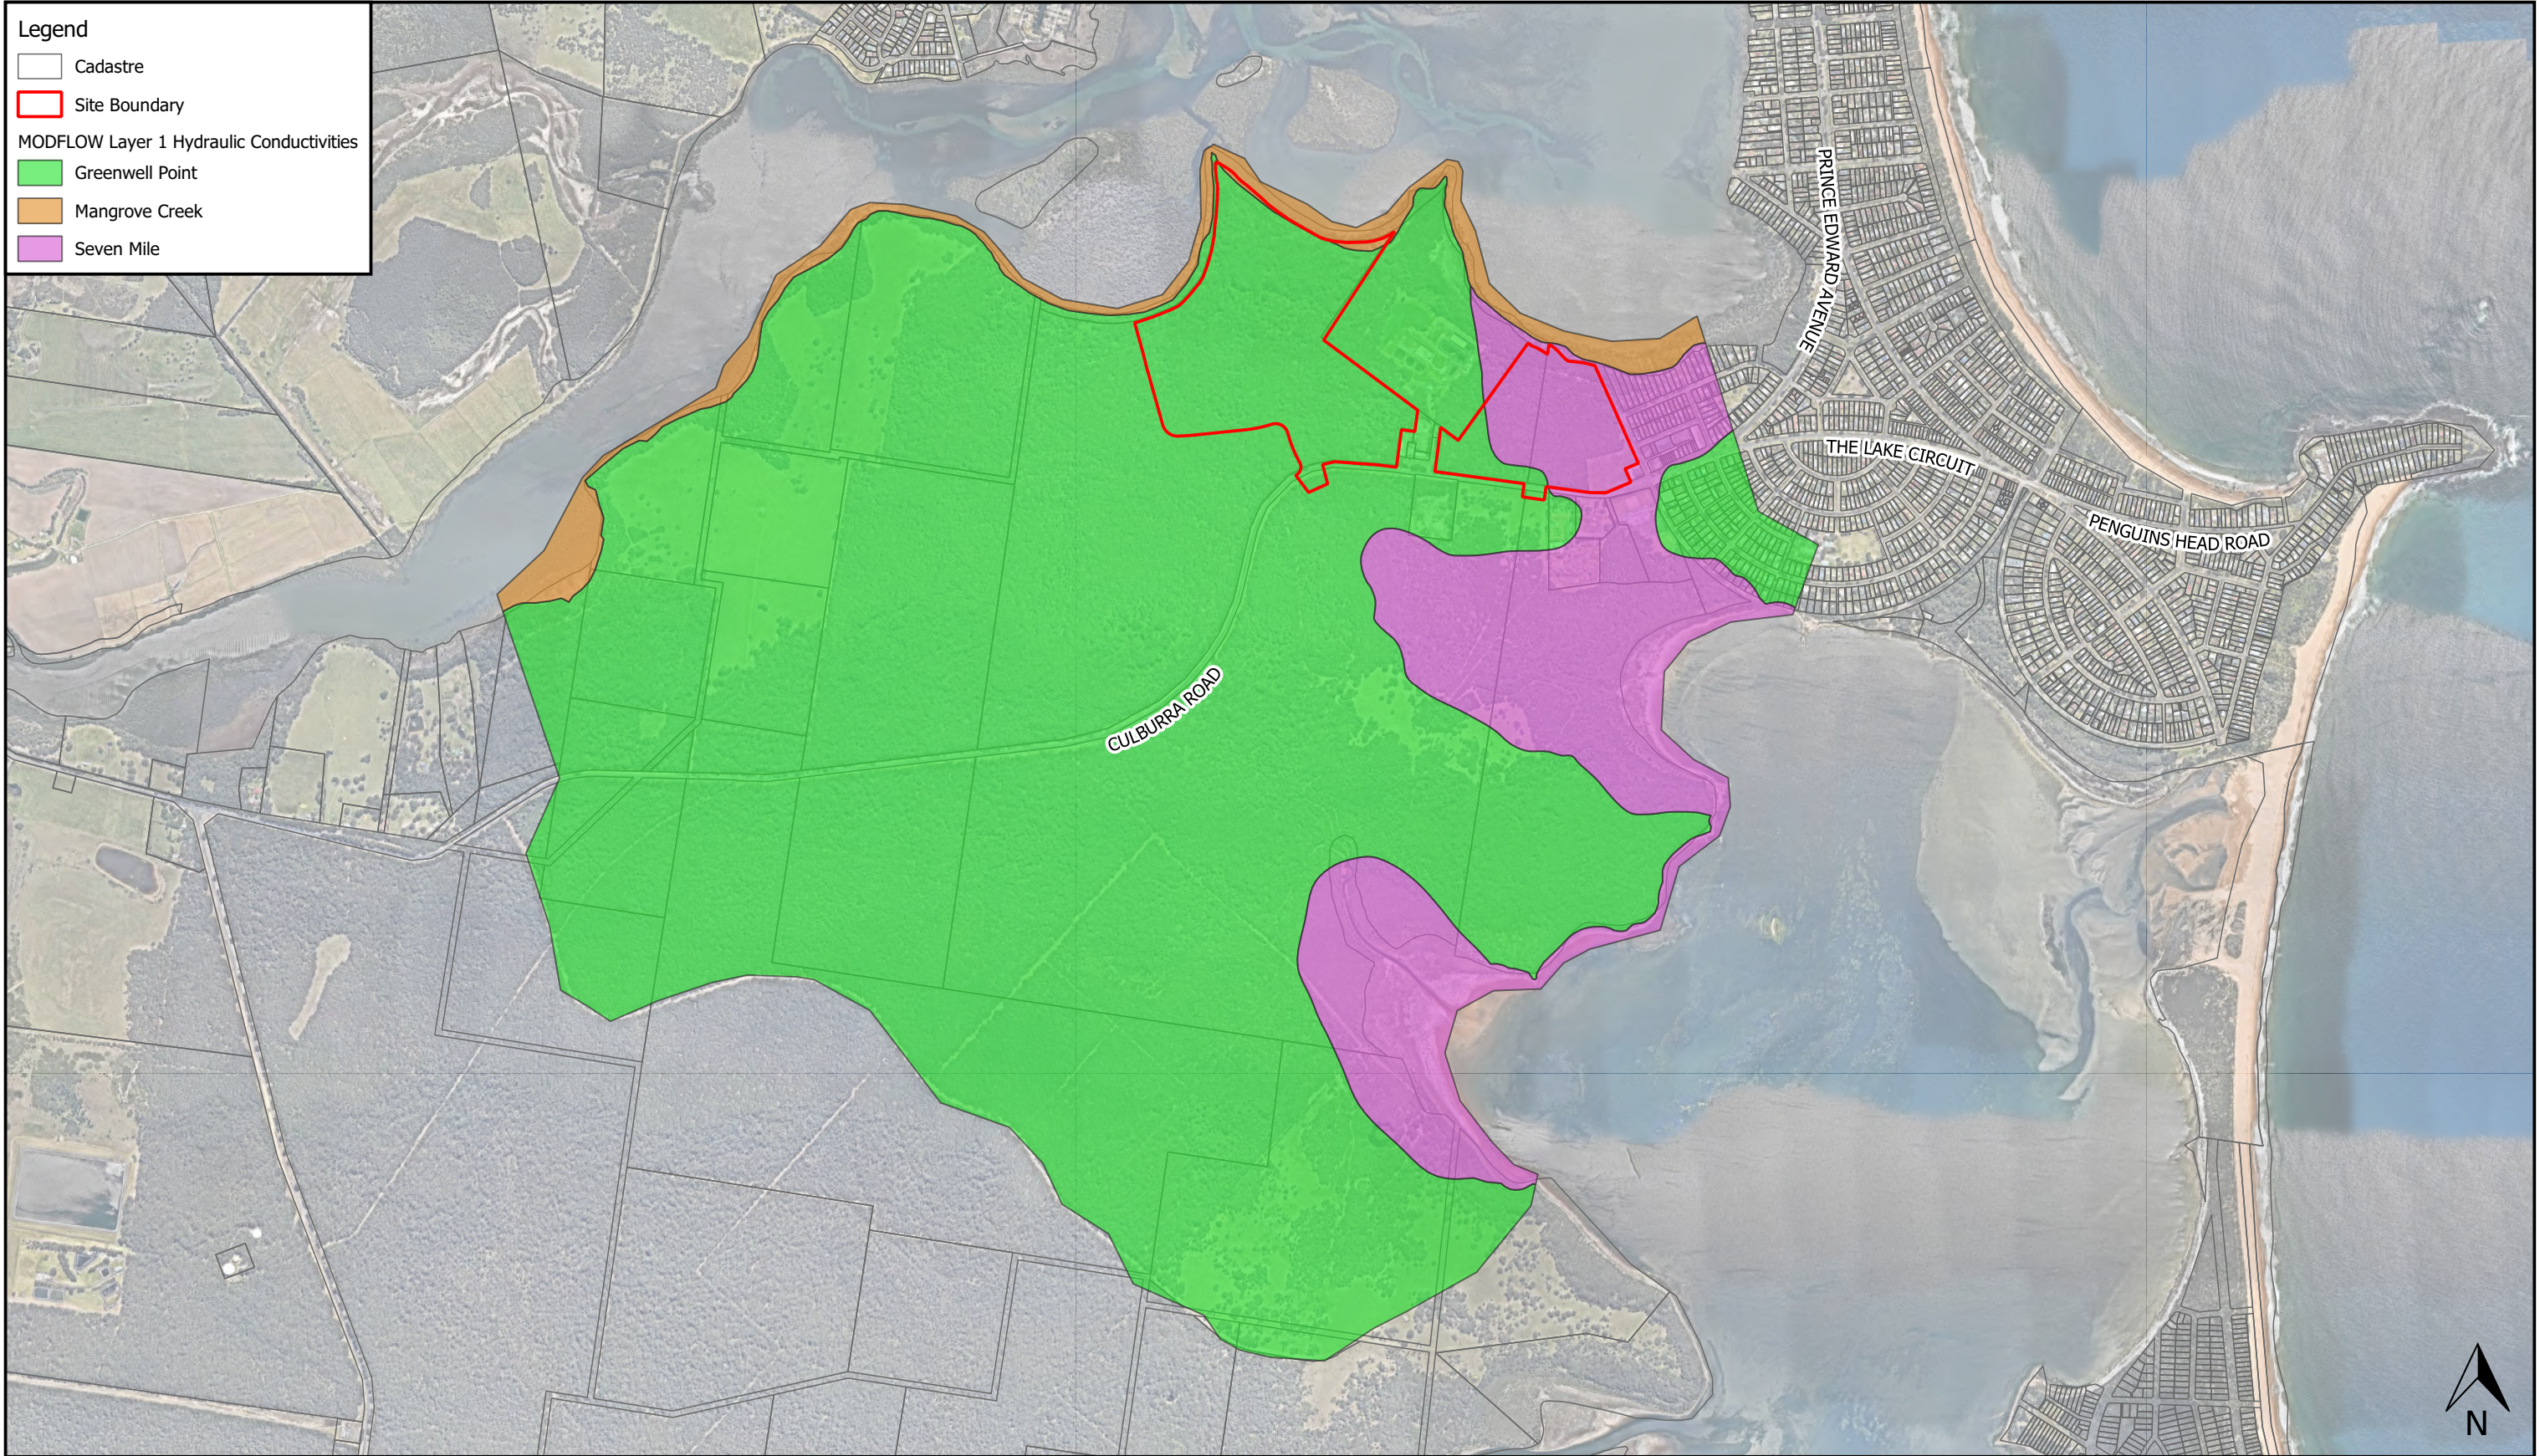
Map Title / Figure:  
**Groundwater Model Extents, Grid Configuration and Boundary Conditions**

- Cadastral
- Site Boundary
- MODFLOW Layer 1 Hydraulic Conductivities
  - Greenwell Point
  - Mangrove Creek
  - Seven Mile

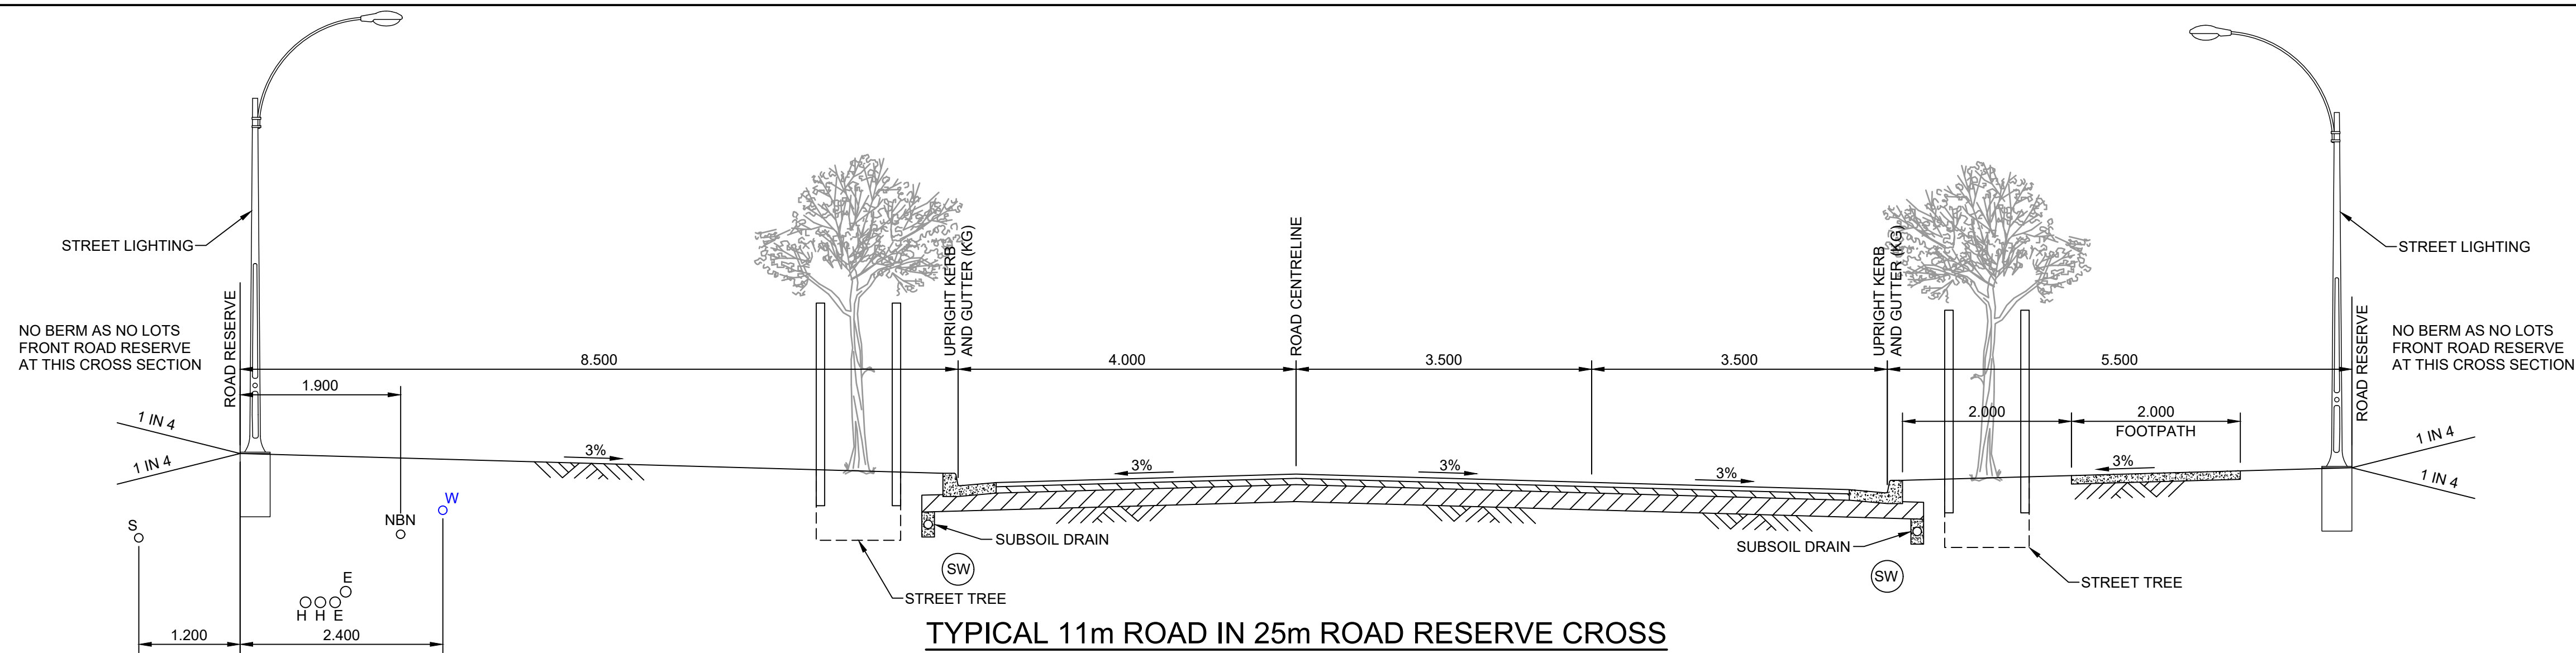
**TYPICAL 11m ROAD IN 25m ROAD RESERVE CROSS SECTION FOR ROAD 01**  
SCALE 1:50

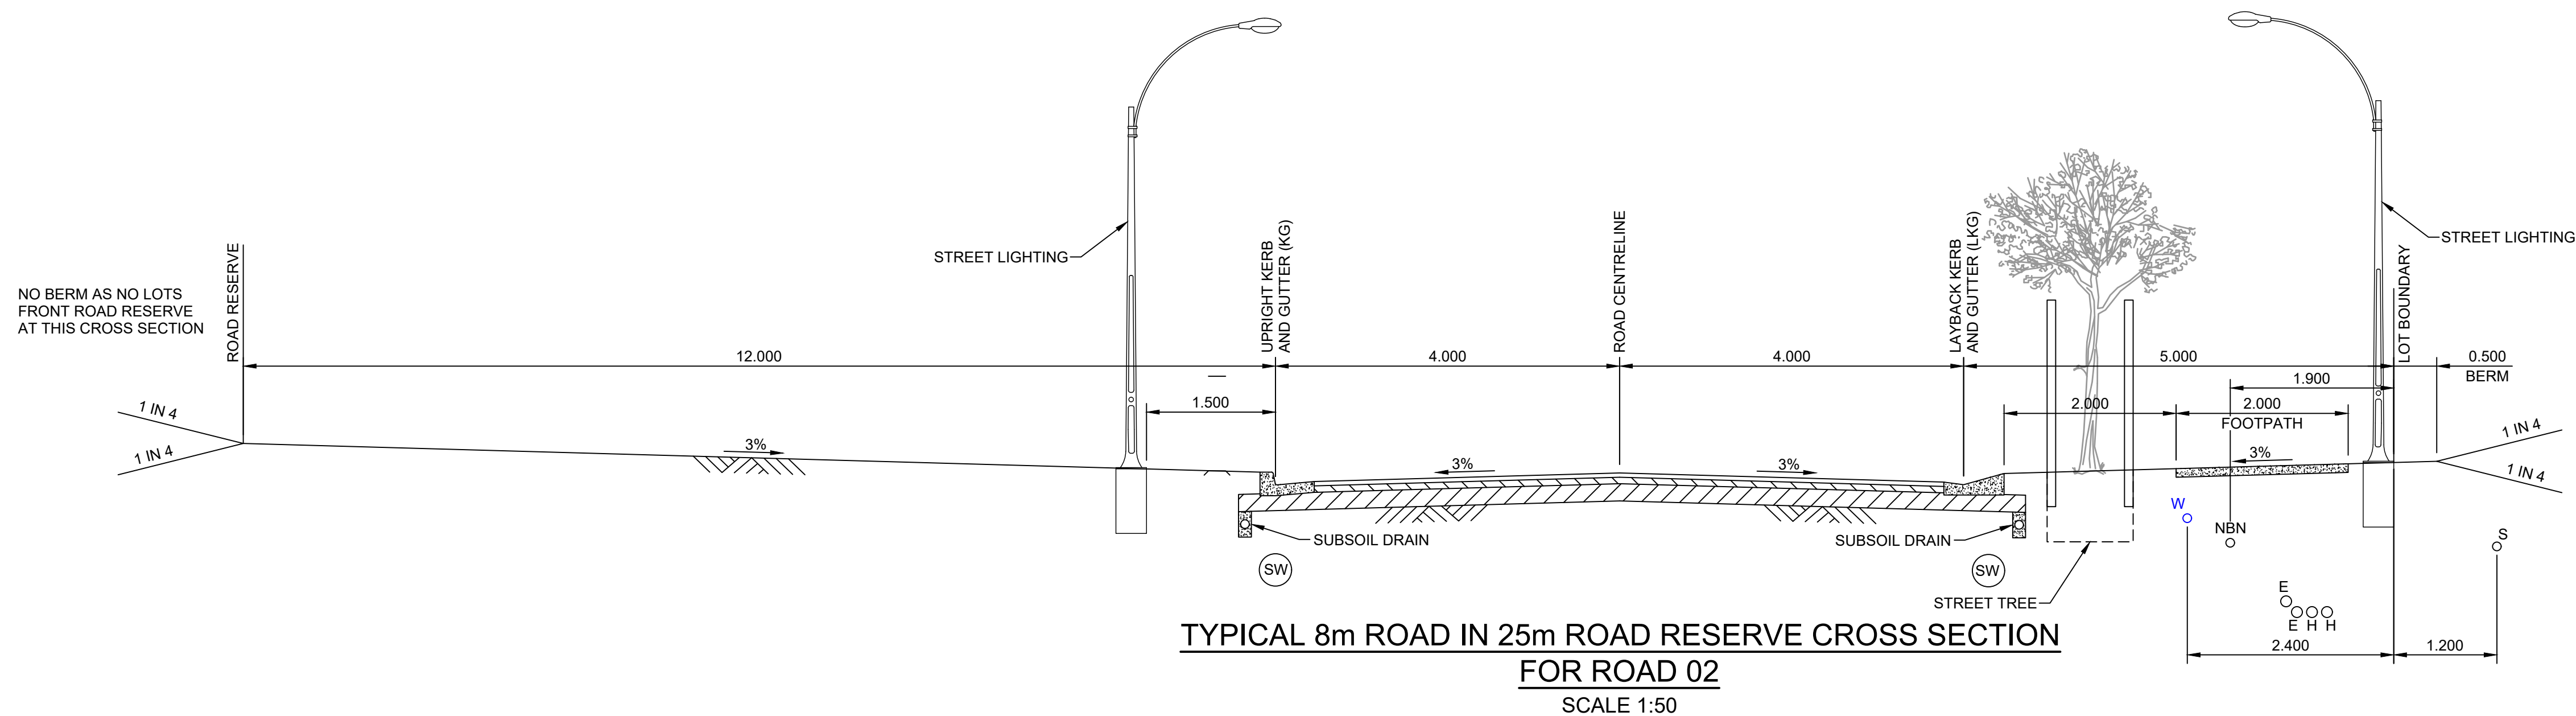
**TYPICAL 8m ROAD IN 25m ROAD RESERVE CROSS SECTION FOR ROAD 02**  
SCALE 1:50

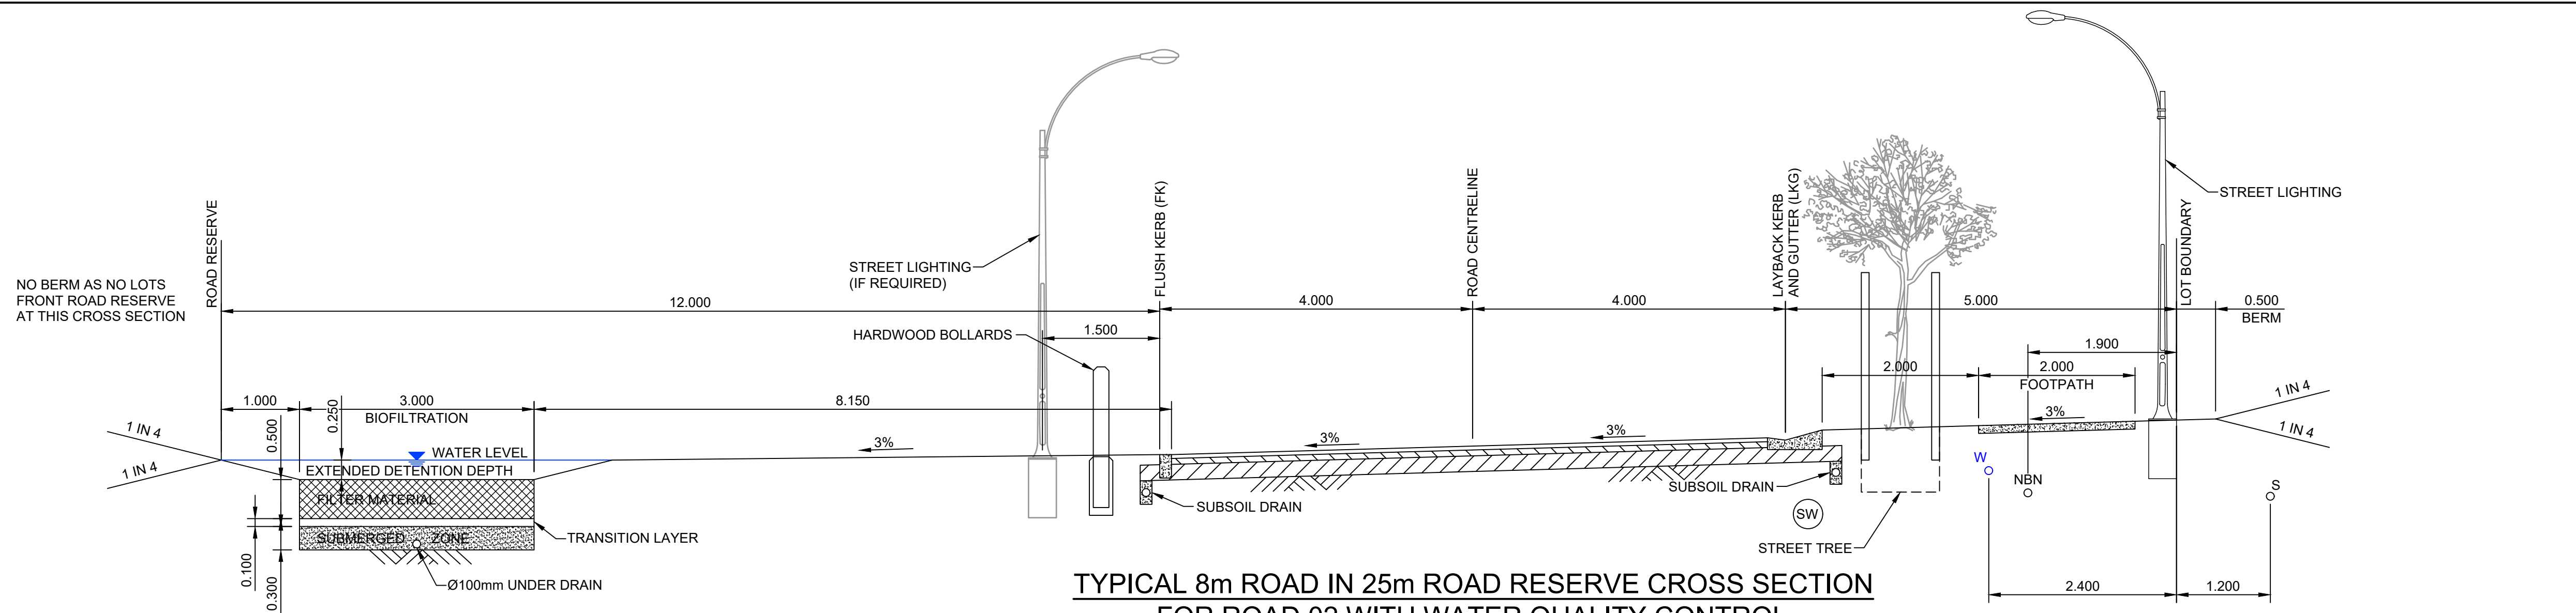
TYPICAL 8m ROAD IN 25m ROAD RESERVE CROSS SECTION  
FOR ROAD 02 WITH WATER QUALITY CONTROL  
SCALE 1:50
